TROUBLESHOOTING & MAINTENANCE

W34 Yard Hydrant Packing Replacement

Rev 06/15 Form No.TMYH-1.104

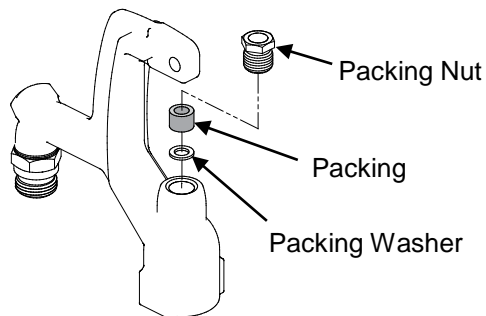
5. Remove the Link Bolt and Link Spacer then remove and set aside the Handle and Linkage Assembly. Fig 1
6. Remove the Packing Nut. Fig 2
7. Dig out the graphite Packing with a screwdriver or other instrument. **Note:** This operation will destroy the Packing and require a new Packing #10101.

8. The Packing Washer #10102 may be reused.
9. Install new Packing #10101.
10. Reinstall the Packing Nut - *do not tighten*.
11. Reinstall the Handle and Linkage Assembly.
